Review of the Rossiter Road and Widcombe Parade Scheme

Widcombe Association
December 2015

ROSSITER ROAD REVIEW

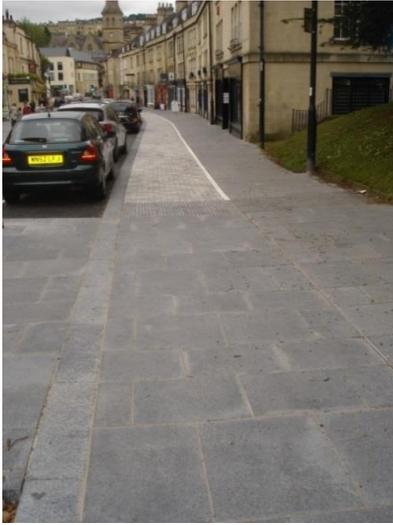
The cycle lane illustrating the confusion caused by the switch in materials.

It does raise the question of why the block paving was not carried through, or alternatively, why the Courtstone was not used throughout. We also query why a white line was used to delineate the cycle lane from the footpath in the section that is block paved. It is noted that a white line has not been used in the London Road scheme where there is a similar juxtaposition of paving and blocks denoting cycle lane and footpath.

There is a need to clarify the definition of the cycle lane. Installing cycle symbols in the paved areas should help. The signing of the cycle route needs to be clear and unambiguous, and set at a height suitable for cyclists.

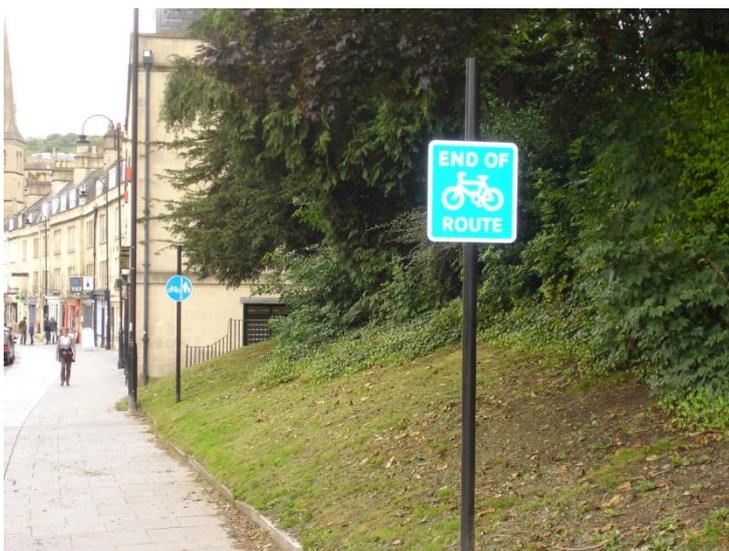
The signing of the cycle lane is equally unclear, with signs in close proximity to each other giving apparently contradictory advice. Thus there is uncertainty for pedestrians as to whether or not they are on the cycle lane. It is also confusing to cyclists. It should be noted that cyclists are using the cycle lane in both directions throughout its length.

Confusing signs for the cycle lane. These signs are also poorly installed.

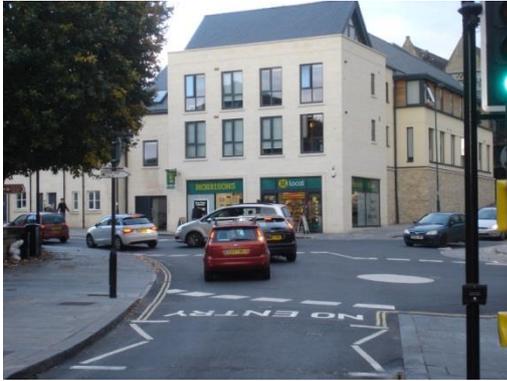
White Hart junction showing traffic queueing back from A36, and vehicles on Widcombe Hill stopped so as to enable vehicles from Widcombe Parade to turn right to either Prior Park Road or Widcombe Hill.

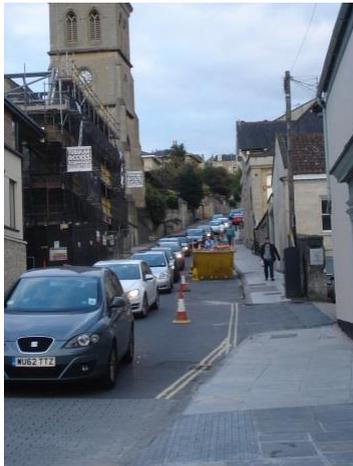
Evening peak hour queue on Widcombe Hill. On the evening this photo was taken, the queueing lasted for no more than 15 minutes.

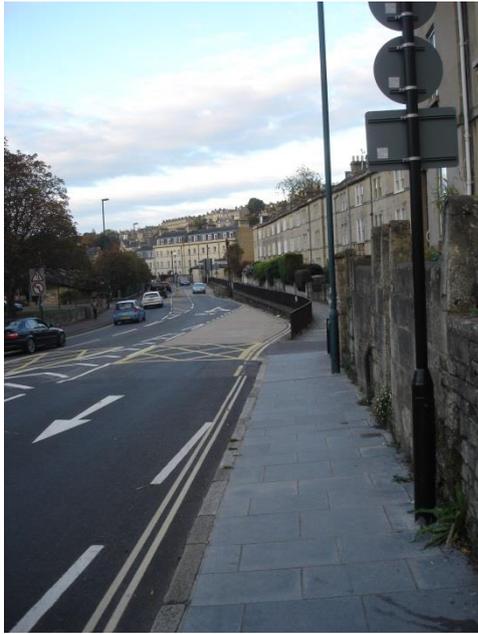
A major flaw in the operation of the scheme is that drivers moving westwards along the Pulteney Road continue to ignore the new signage, and bear left towards the White Hart junction, expecting to drive through the Parade. Most realise their error and U-turn and travel back to the junction with Rossiter Road by the hotel. A few still drive through the Parade the “wrong” way.

Junction of A36 and the lower Pulteney Road showing the painted road surface to indicate the access to Widcombe.

In the interests of safety, there needs to be greater distinction between the main road (A36) and the subsidiary road (lower Pulteney Road). This could best be done by making the left turn into lower Pulteney Road more obviously a turn from a major to a minor road. One way would be to introduce a more clearly defined entrance to the lower Pulteney Road by building a new kerb line to replace the coloured surface. This would also increase safety for pedestrians at the crossing to and from St. Matthews Place

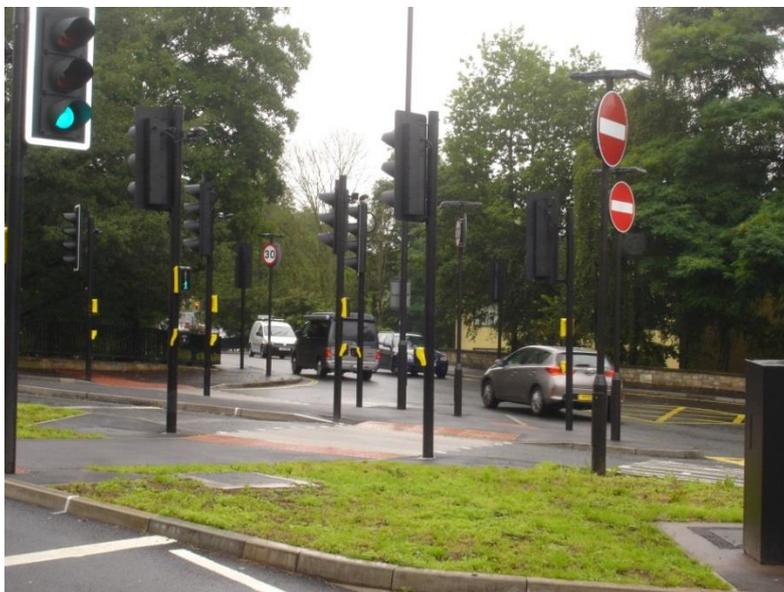
Junction of Pulteney Road and Rossiter Road (the Eastern junction) showing the multiplicity of poles for traffic signals, signs and street lights.

The positioning of the signs, signals and lighting columns appear to have been carried out with insufficient co-ordination between those responsible. The result is that, in places, they interfere with each other. The result is confusing to road users and introduces potential hazard.

It is recommended that the Council reviews the excessive level of signalling and road signing at the two principal junction on A36 in order to reduce confusion and improve safety for road users. This will require reduction of conflict between signs, signals and lighting columns. The Council is also

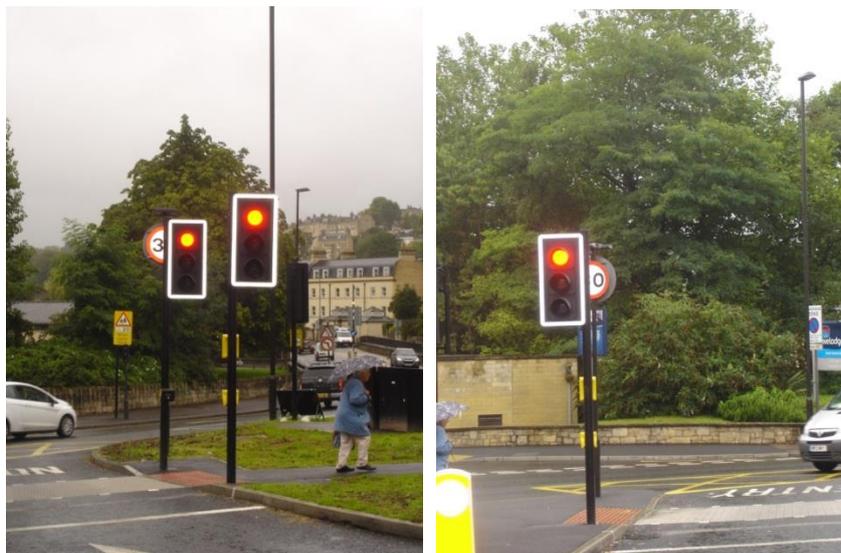
- a) 30 MPH sign obscured by the signal head in front of it,
- b) Right hand secondary could be located on the lighting column on the north side of Pulteney Road,
- c) The first right hand signals could be replaced by a control post.
- d) The junction does not need three signal heads.

Traffic signals at the eastern junction obscuring 30MPH signs

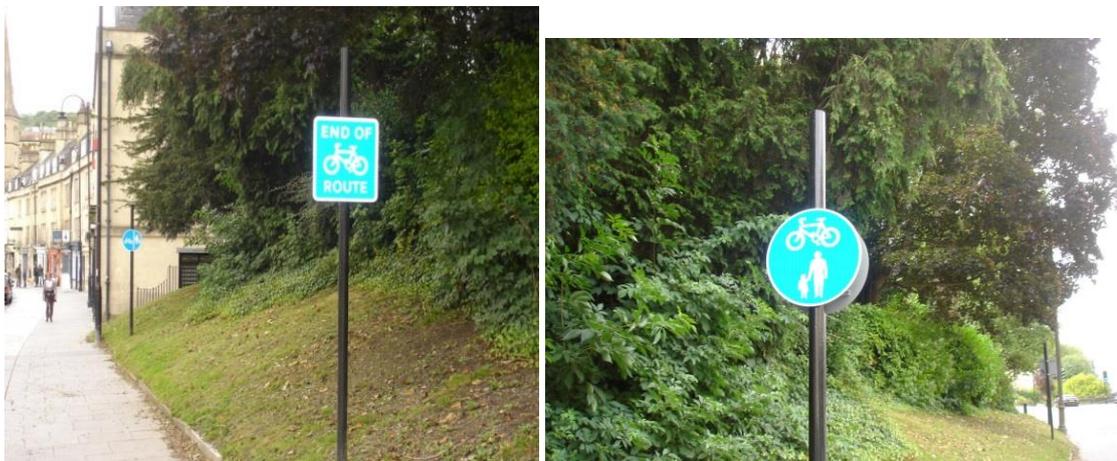
Showing the poor installation of signs, where the poles should not extend above the signs.

As a matter of principle, signs should be mounted on poles of appropriate height. Where there is an excessive length of pole above the sign, the pole should be shortened.

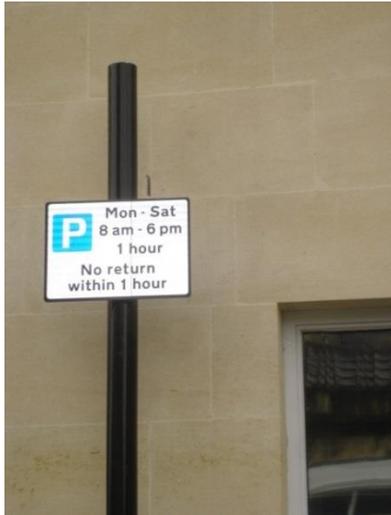
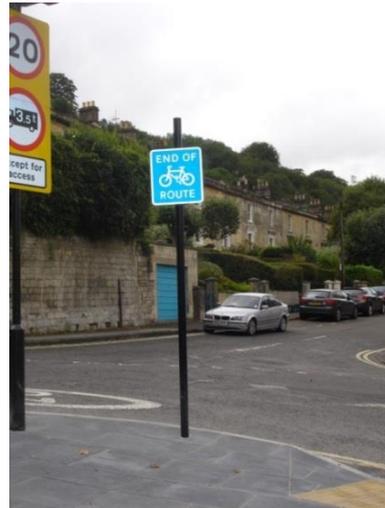
Showing the poor installation of signs, where the poles should not extend above the signs.

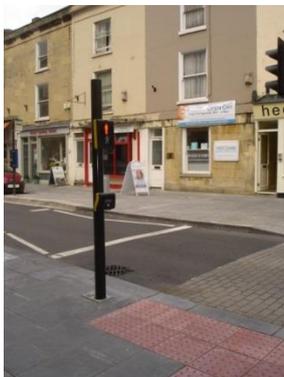
Clumsy and intrusive control column within the Parade

- a) The control post at the signal crossing could be smaller with a combined button and display.

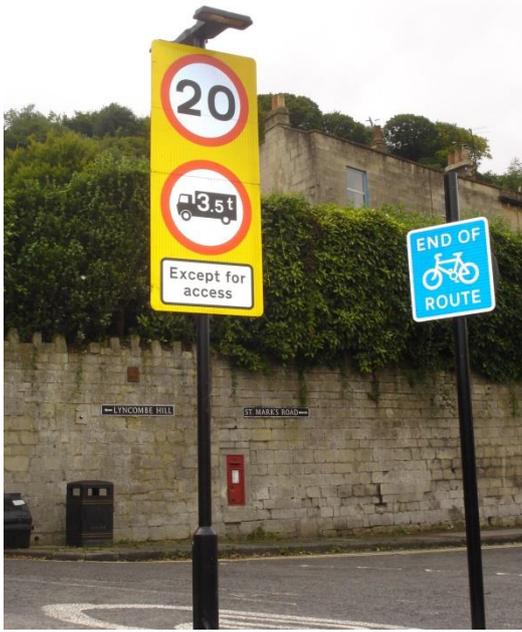
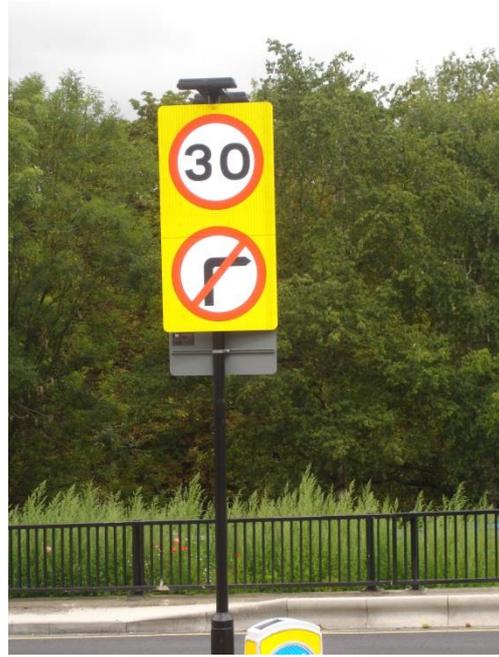
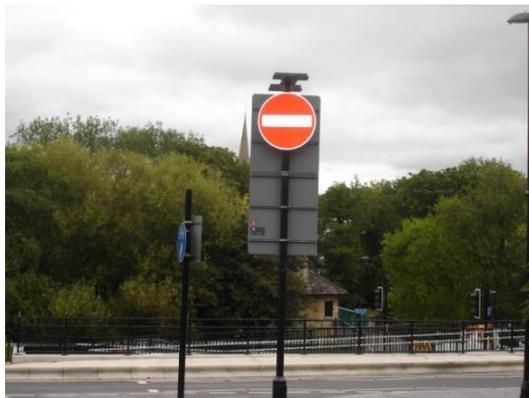
- a) The crossings of Claverton Street and Rossiter Road via the new ramp. Both crossings have three signals. As each road is one-way, only two signal heads are required at each crossing.
- b) The reduction in signs at the bottom of Lyncombe Hill is welcome, however, more thought could have been given to the way the remaining ones are displayed.
- c) The three large signs with yellow backing boards are unnecessary and inappropriate in a conservation area. Also the back of one of them is fully exposed to those going downhill. The sizes of the individual signs on these boards could be reduced, as they have been on the signs on Pulteney Road where it leaves Rossiter Road at the eastern junction.

Excessively intrusive signing at the foot of Lyncombe Hill.

e) The sign indicating end of cycle route could be put on the adjacent lamp post and that post removed. (see photo on previous page)

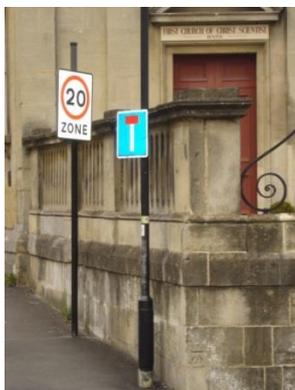
d). The 20MPH sign into St Marks Road is unnecessary. It is clearly within the 20MPH zone, and the configuration of the road makes it virtually impossible to exceed 20MPH in any case.

Poor signing at the entrance to St Marks Road. The 20MPH sign is unnecessary as the road is clearly within the 20MPH zone. If a 20MPH repeater sign is considered appropriate, it could be put on the lighting column.

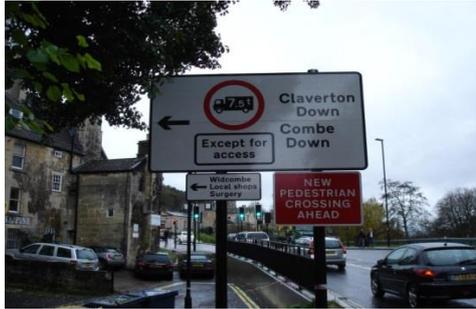
- a) The appropriateness of the sign, located just before the left turn into the Parade from Rossiter Road, is queried. It is a very large sign for the nature of the message that it conveys. The route to Combe Down via Prior Park Road from the east has already been signed from A36 via the lower Pulteney Road. We suggest that this sign is unnecessary and should be removed. It encourages additional traffic through the Parade and is disproportionately large and unsightly.

Large and unnecessary sign on Rossiter Road

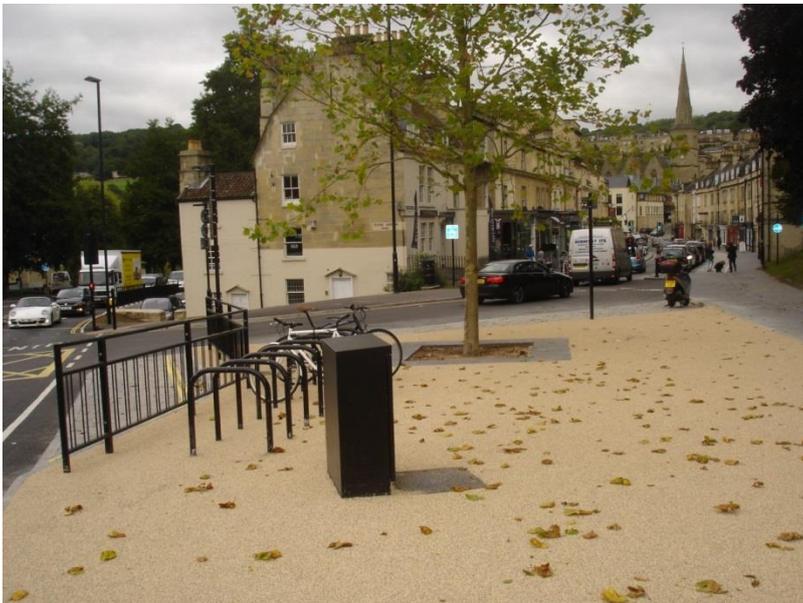
The area at the western end was not subject to a detailed urban design – the layout of the area has been ad hoc. A conceptual plan was produced pre-contract, but the implementation of the area is not consistent with it. The specimen tree is not in the position indicated on the original plan, nor as indicated on the plan supplied by the Council following the installation of the tree. The various components are randomly positioned and very little thought has been given to the overall design. No detailed design drawings were shown to the Widcombe Association until October 2015 on a drawing showing the proposed planting. Even that drawing showed the specimen tree at the opposite end of the area.

The western end of the Parade indicating the random positioning of the tree and the signal control box.

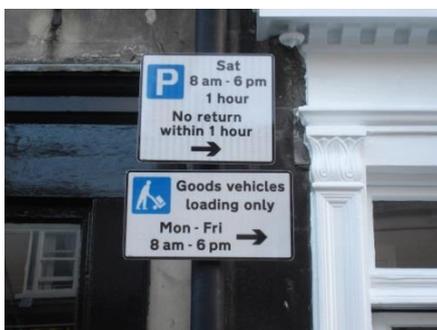
There is an issue with the servicing bay in the middle of the Parade (adjacent to the shop Flamingo). Two signs denoting the loading bay have been erected but they are ambiguous both in terms of the conditions of use of the bay, and also in defining the location to which they apply (see photo below).

Ambiguous signs indicating parking restrictions in the loading bay in Widcombe Parade.

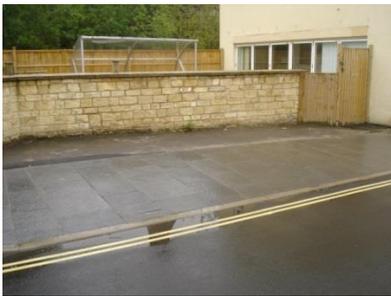
On Pulteney Road south side a dropped kerb has been provided by the rear yard to the new development with a semi-formed parking bay by the yard. It encourages parking on the pavement (observed on several occasions) as the semi-formed bay is not wide enough for a parked vehicle.

Dropped kerb in Pulteney Road, but no proper parking bay.

The Council is requested to replace the dropped kerb by a standard height kerb in order to deter parking at this location.

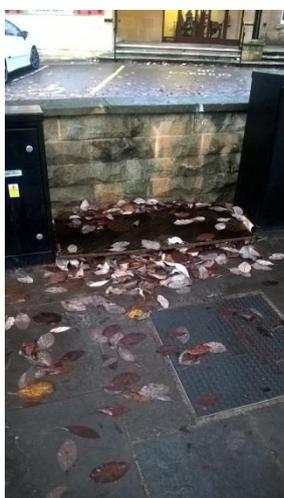
Position for a possible future signal control box with temporary cover.

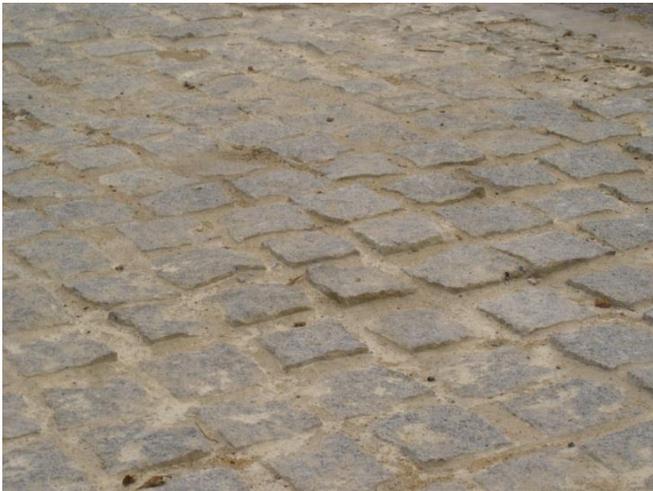
20. Setts in layby at western end of the Parade poorly laid.

Setts at western end of the Parade
